# Geotechnical Assessment for SYD08: 57 Station Road, Seven Hills, NSW

P2007944JR05V05  
May 2022

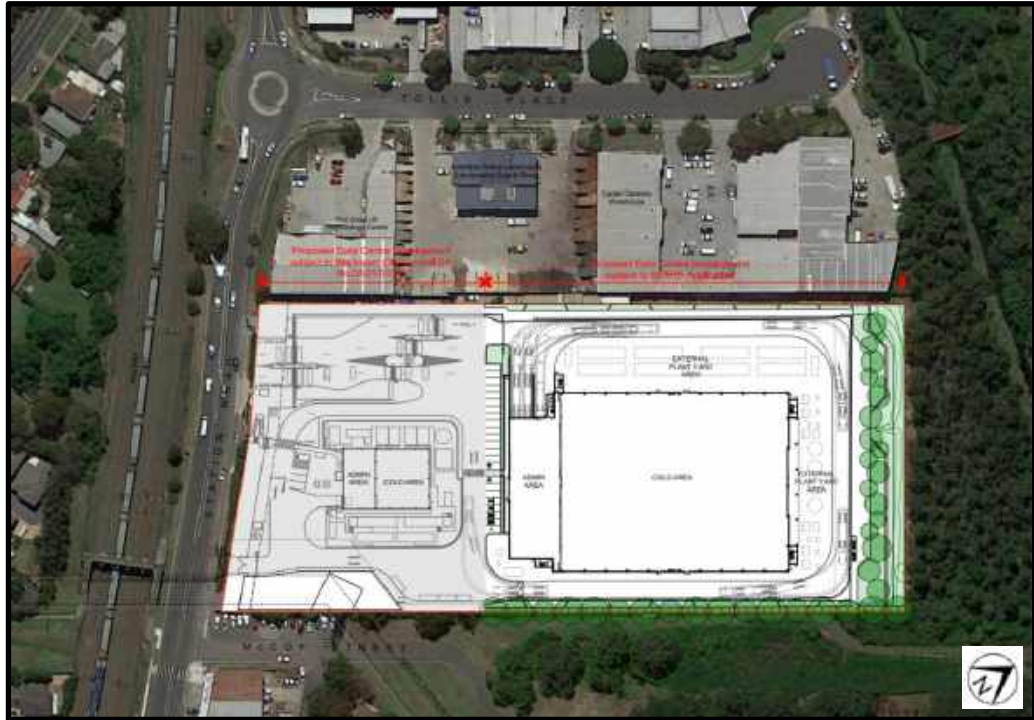
**Figure 1:** Site Plan for approved data centre on Site, under DA-21-01058 (Source: DEM architects).

The existing approval permits tree removal, bulk earthworks, and drainage works across the entirety of the site, with the construction of a data centre on approximately the front third as depicted in the Figure 1 below. The balance of the site is the location of the proposed SSDA, excluding bulk earthworks.

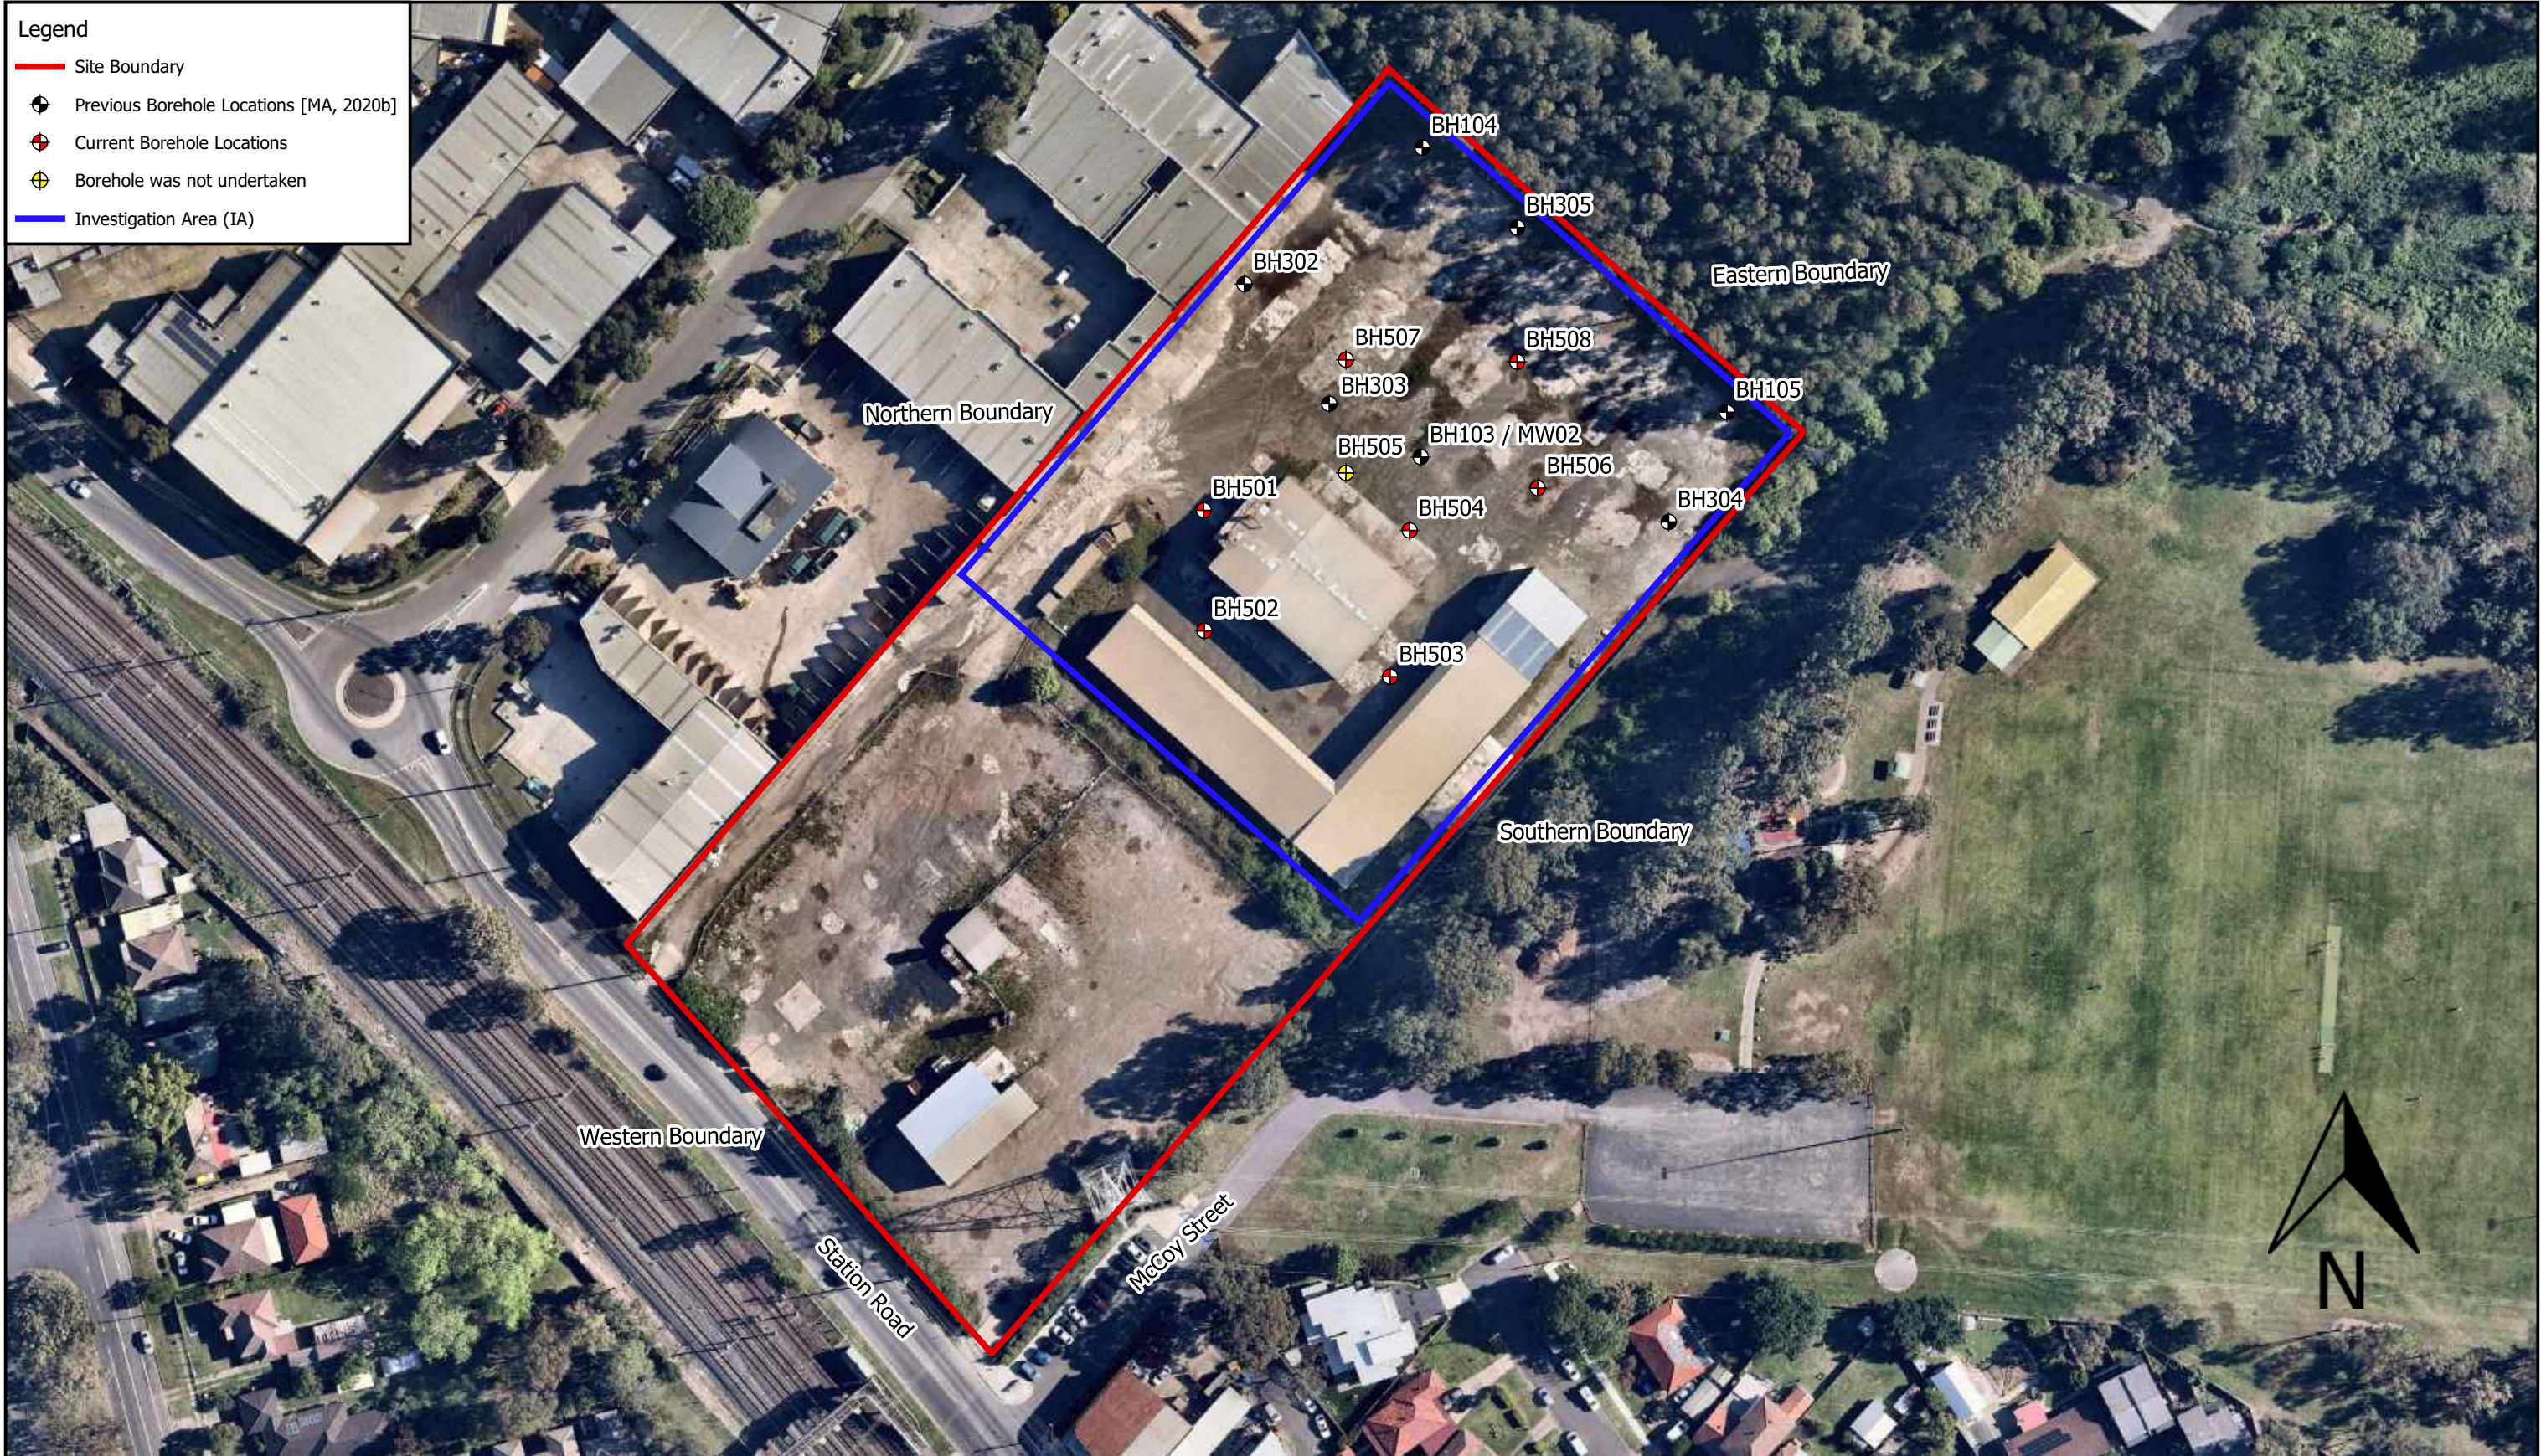
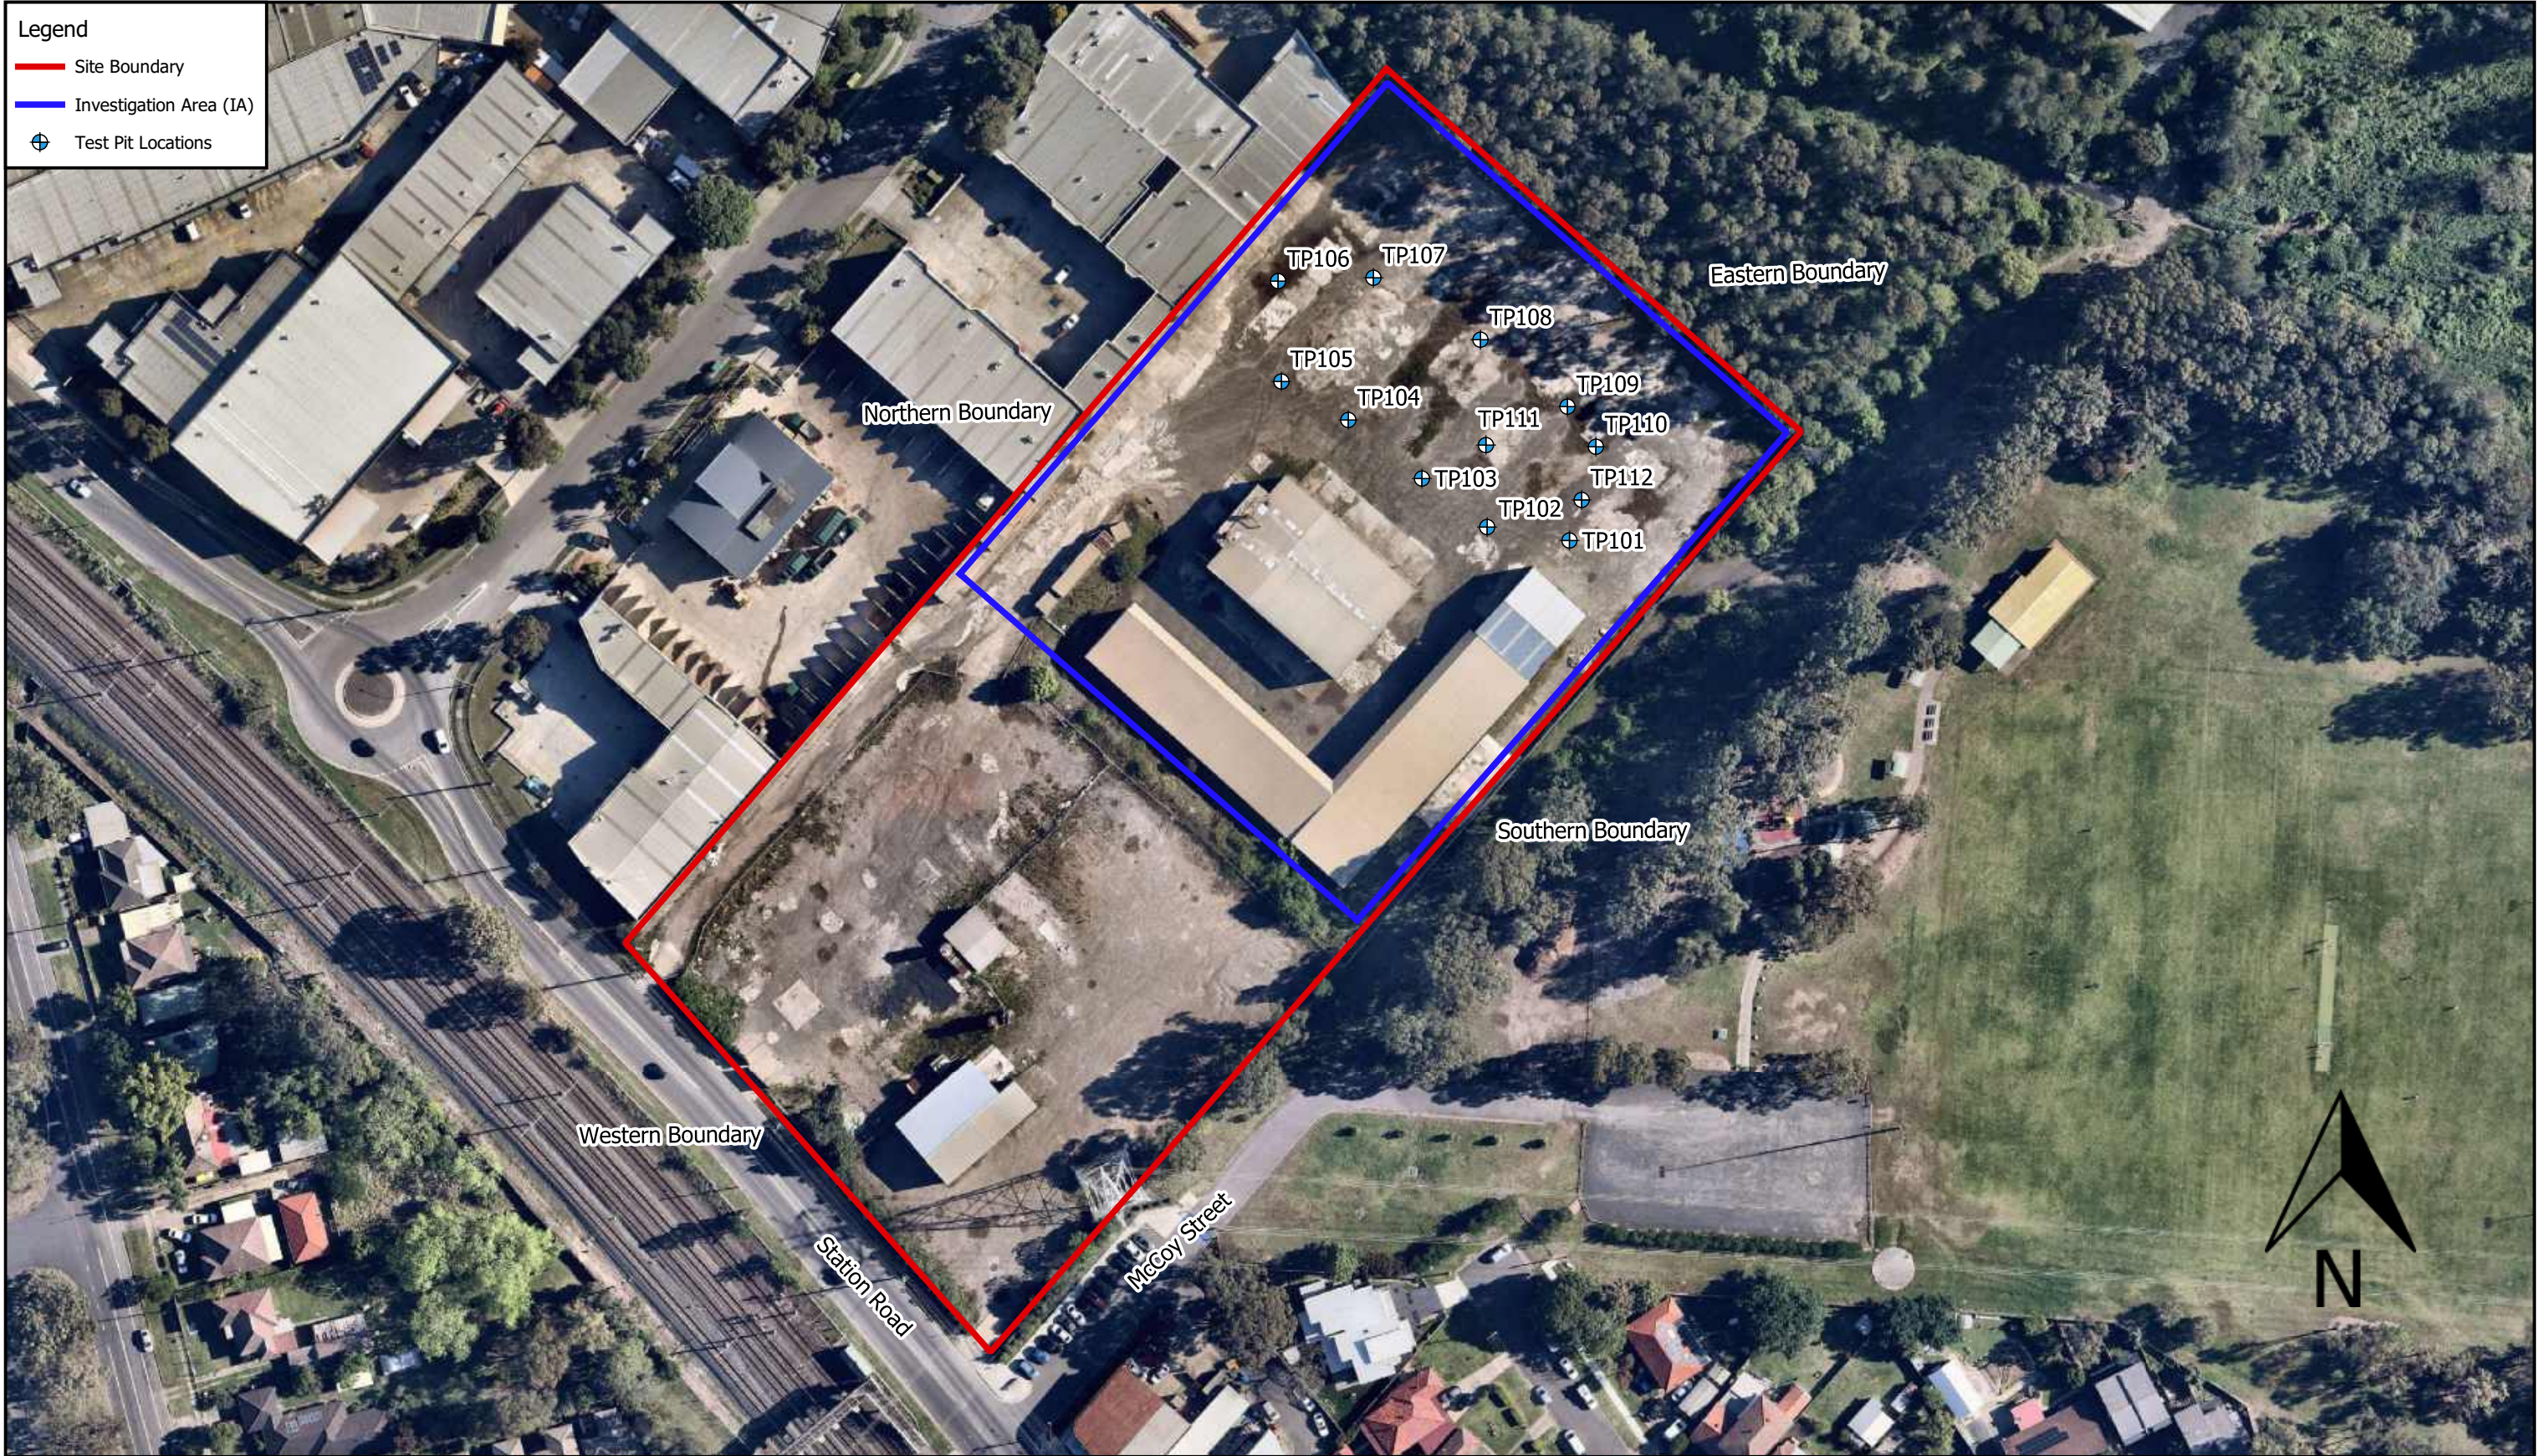
Map Title / Figure:  
**Geotechnical Investigation Plan**

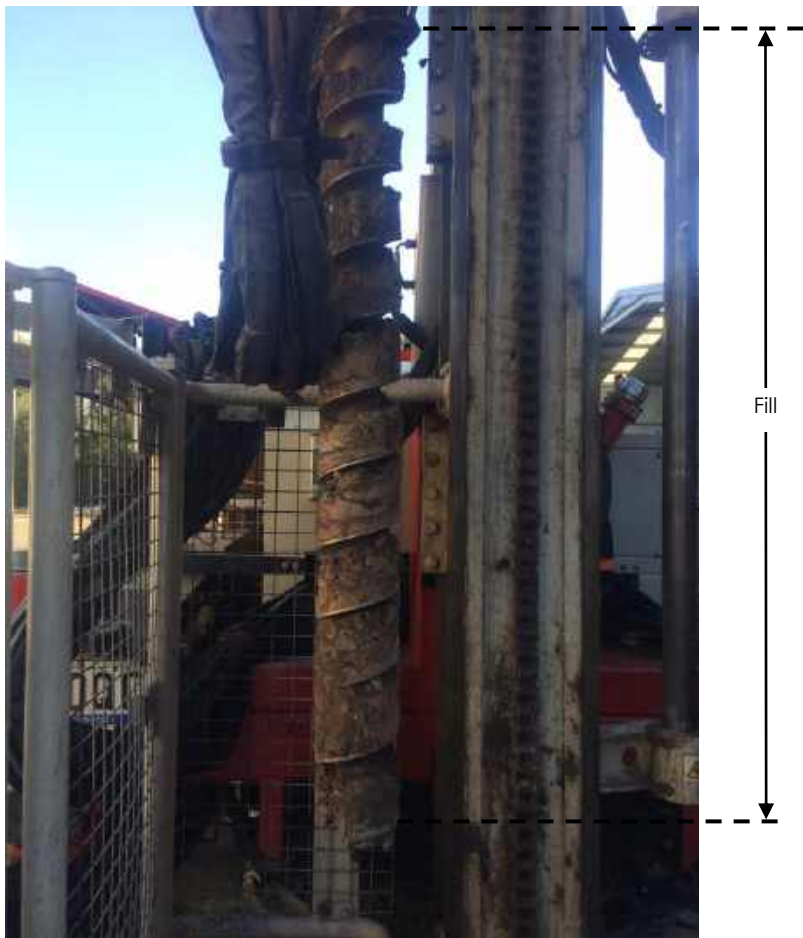
**Photo 1:** Retrieval of fill materials (from ground surface to a depth approximately 1.5 m) from the auger at BH503 (viewing east).

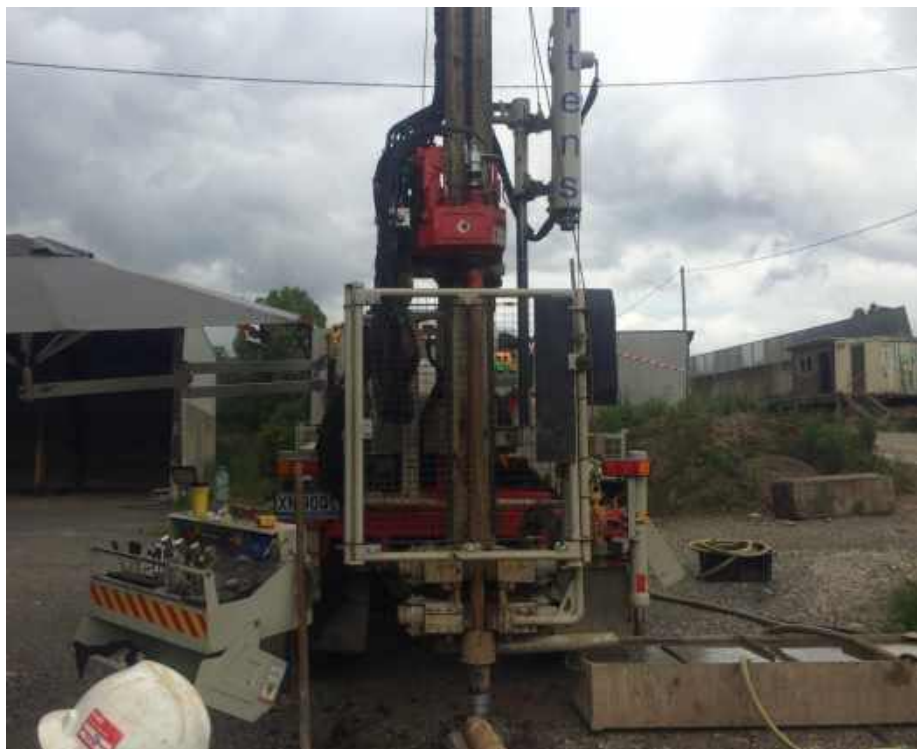
**Photo 3:** Progress of rock coring at BH501 (viewing west).

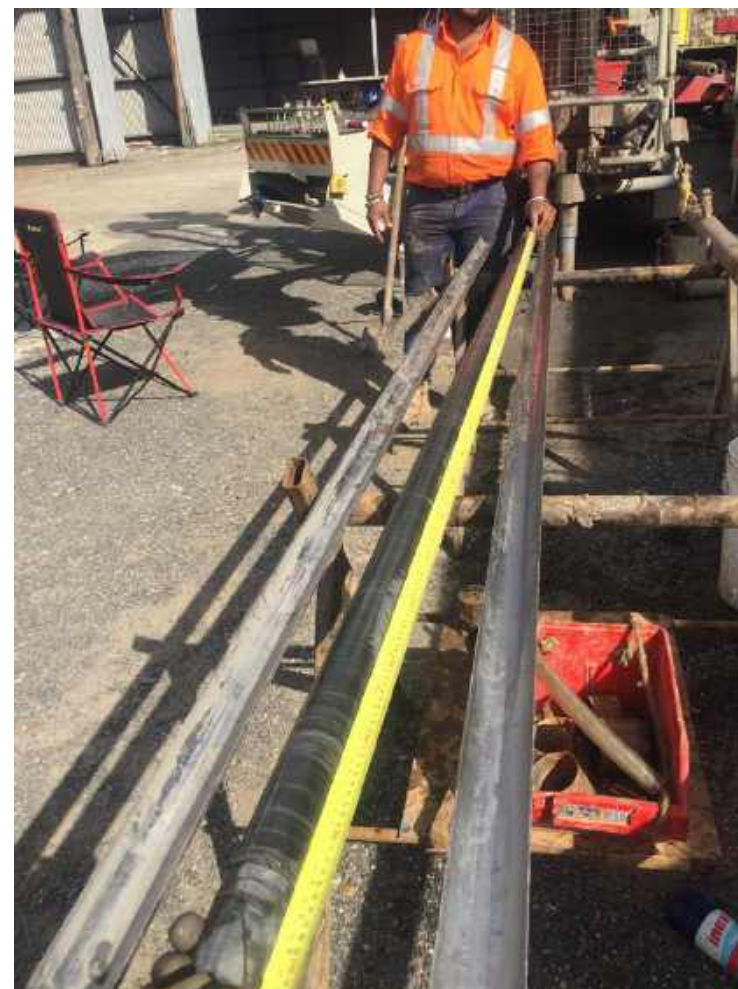
**Photo 4:** Retrieval of rock core (depth approximately 2.3 m to 5.08 m) from BH502 (viewing northwest).
